## LETTERS

## Implantable cardioverter-defibrillator troubleshooting diagnosis with the contribution of an electrocardiogram

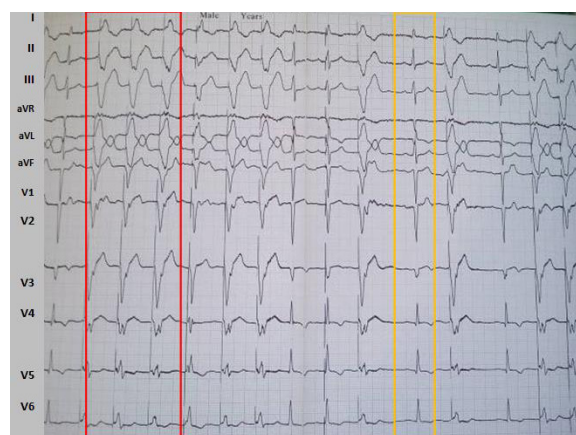
**Figure 1:** Ventricular lead intermittently and unipolar pacing, indicative of ICD's troubleshooting (captured QRS complexes are depicted in the red box, while non-captured QRS complexes are shown in orange).

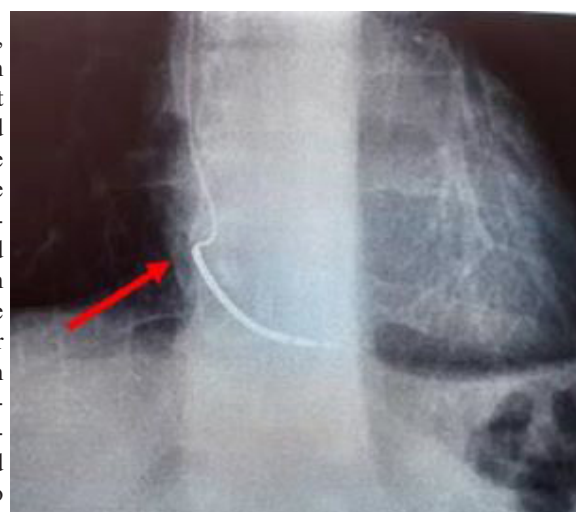
**Figure 2:** Chest X-ray showing ventricular lead dislodgement. The lead dislodgement caused a sharp curve just before the coil of the lead, which conduced to the reduction of the lead impedance because of damage to its insulation.
